TO: All Proposers  
FROM: Lauren Rowley, Purchasing Manager  
DATE: **November 13, 2023**  
SUBJECT: **Addendum #01** – PROPOSAL #24000525- BUILDING AND SAFETY INSPECTIONS  
DIVISION BUILDING RENOVATIONS

BUILDING INSPECTION DEPARTMENT OFFICE RENOVATIONS  
CITY OF FLINT  
1101 S. SAGINAW ST., FLINT, MICHIGAN

FIGURES 1  
Functional Space/Sample Locations

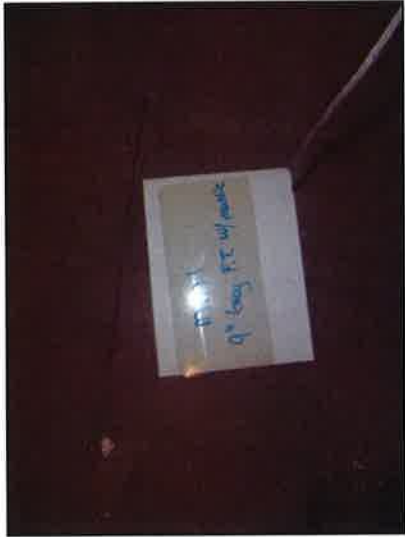
MM1  
9" Gray Floor Tile with Mastic

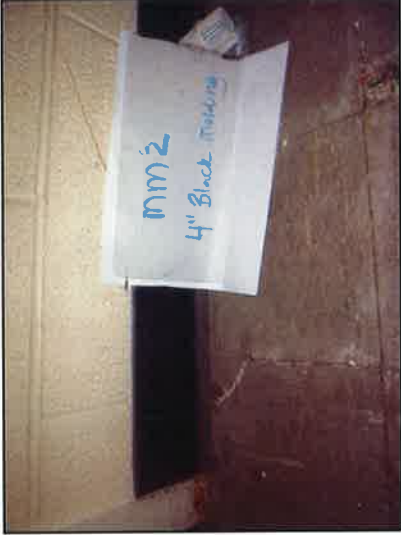
MM2  
4" Black Molding with Glue

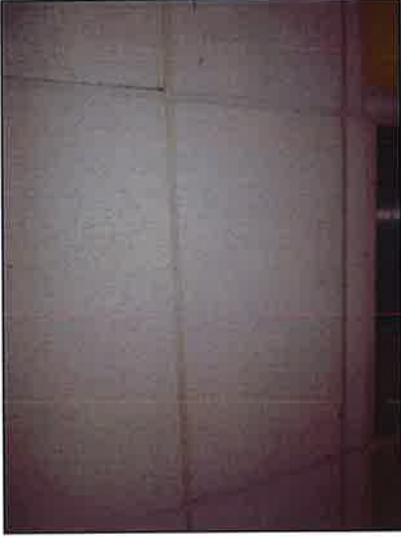
MM3  
2' x 4' White Ceiling Tile with Perforations

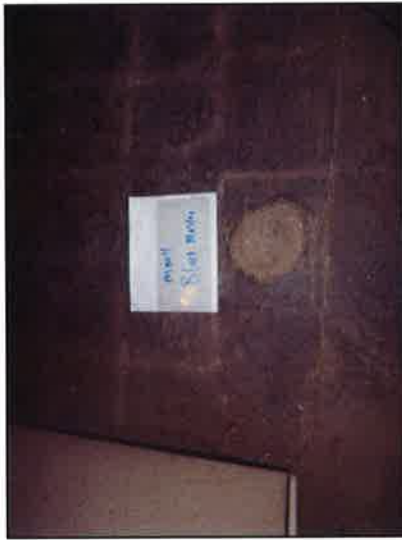
MM4  
Black Mastic

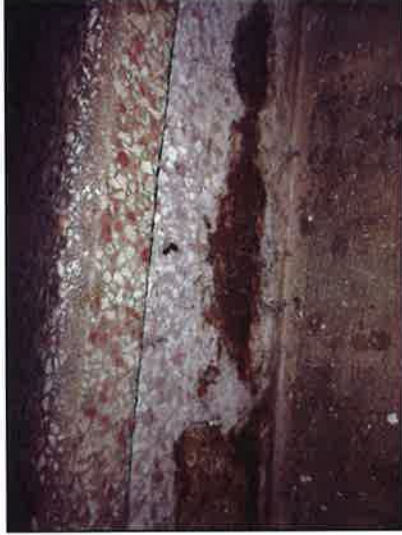
MM5  
Brown Adhesive

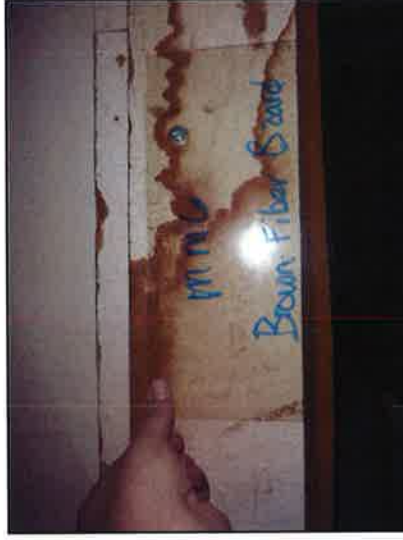
MM6  
Brown Fiberboard

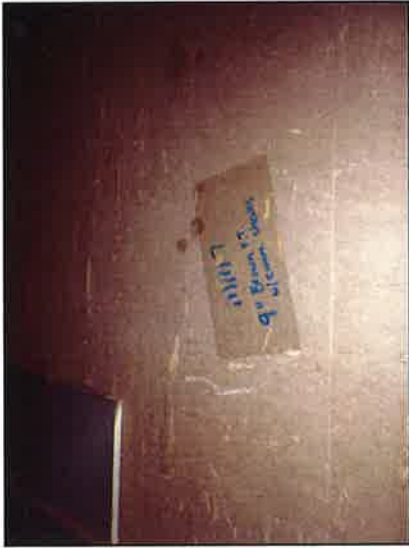
MM7  
9" Brown Floor Tile with Cream Streaks and Mastic

Sample Information	Asbestos Type/Percent	Non-Asbestos
Lab ID #: 68481 - 19 Cust. #: CHSMM7-1 Material: 9" Brown Floor Tile, Cream Streaks Location: FS 12 Appearance: grey, fibrous, homogenous Layer: 1 of 2	Asbestos Present: <b>YES</b> Chrysotile - 10%	Other - 90%
Lab ID #: 68481 - 19a Cust. #: CHSMM7-1 Material: Mastic Location: FS 12 Appearance: black, nonfibrous, homogenous Layer: 2 of 2	Asbestos Present: <b>NO</b> No Asbestos Observed	Other - 100%
Lab ID #: 68481 - 20 Cust. #: CHSMM7-2 Material: 9" Brown Floor Tile, Cream Streaks Location: FS 12 Appearance: Layer: 1 of 2	Asbestos Present:  NOT ANALYZED

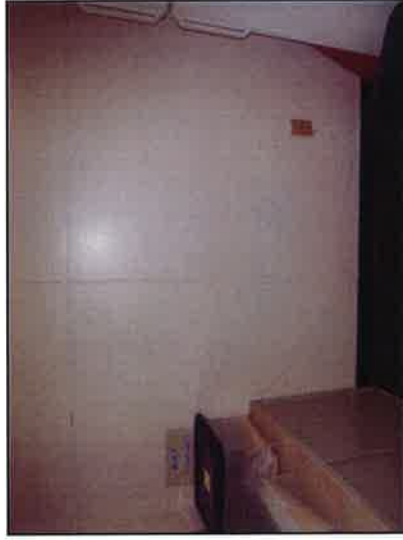
MM8  
Drywall Panels

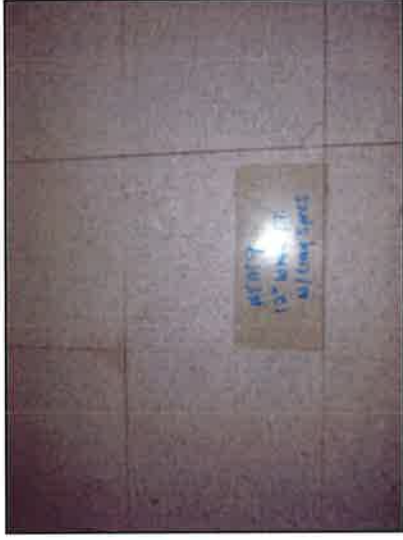
MM9  
12" White Floor Tile with Gray Streaks and Mastic

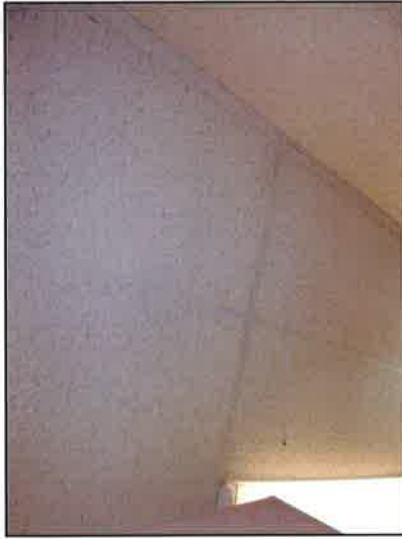
MM10  
2' x 4' White Ceiling Tile with Holes and Perforations

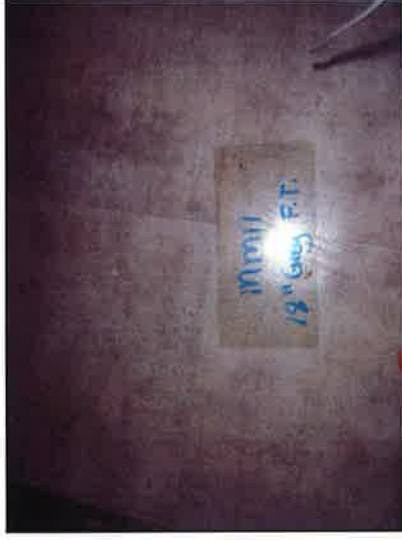
MM11  
18" Gray Floor Tile

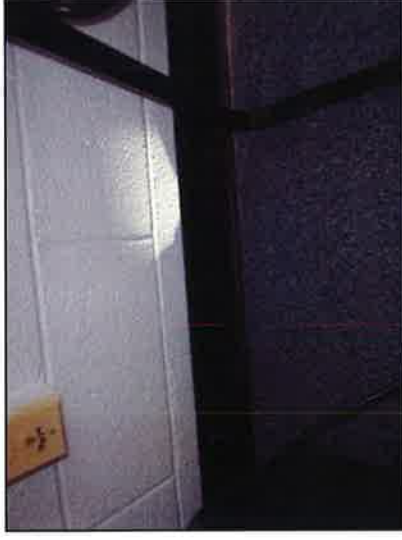
MM12  
6" Black Molding

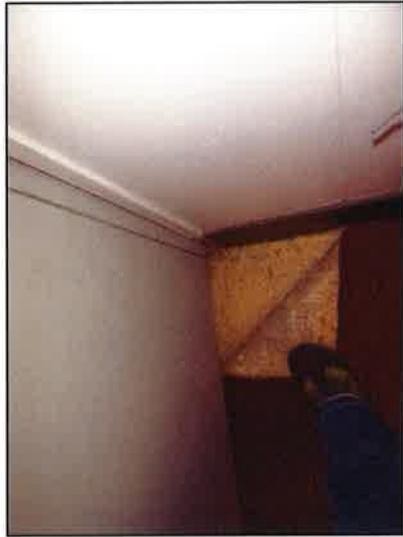
MM13  
Yellow Carpet Adhesive

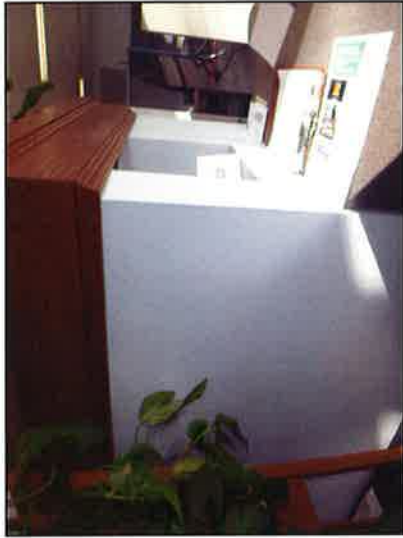
MM14  
Drywall with Joint Compound

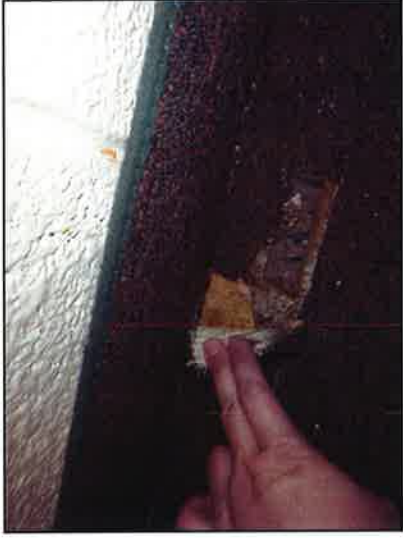
MM15  
Pink Floor Tile with Mastic

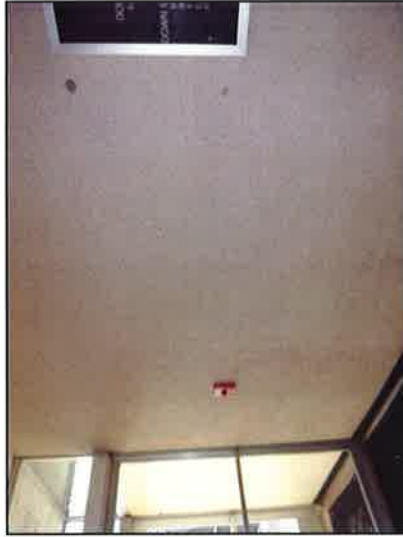
MM16  
Tan Textured Vinyl Drywall

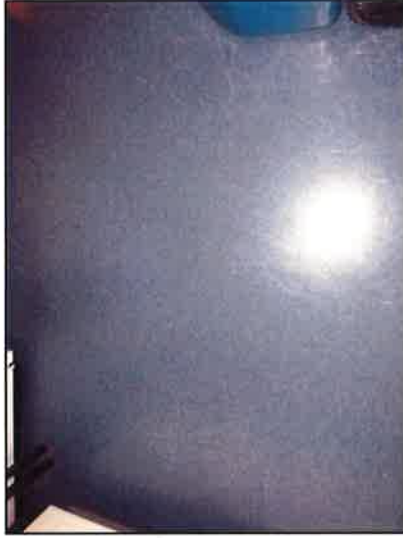
MM17  
12" Blue Floor Tile with Mastic

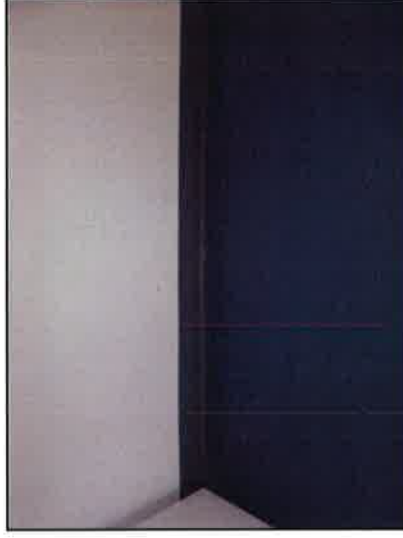
MM18  
4" Gray Molding

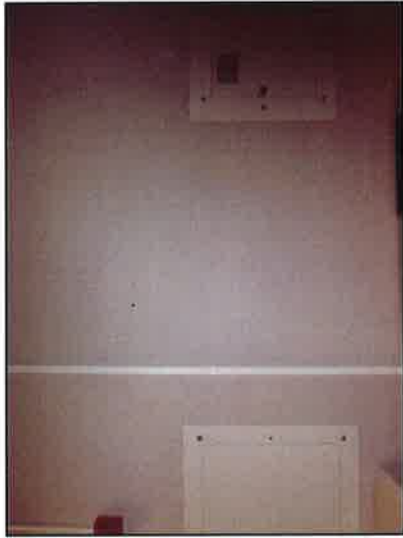
MM19  
Pink Vinyl Drywall

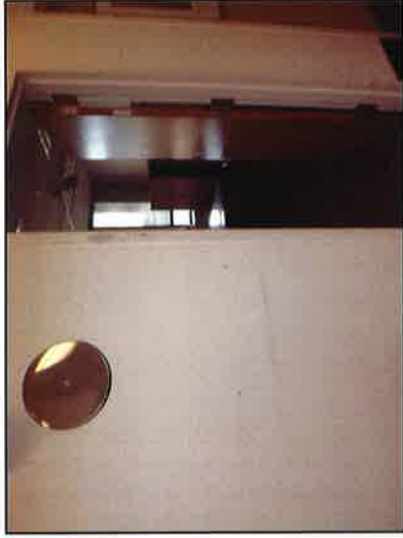
MM20  
White Vinyl Drywall

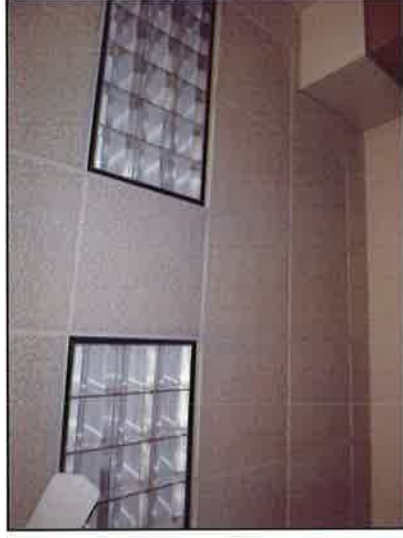
MM21  
2' x 2' White Ceiling Tile with Perforations

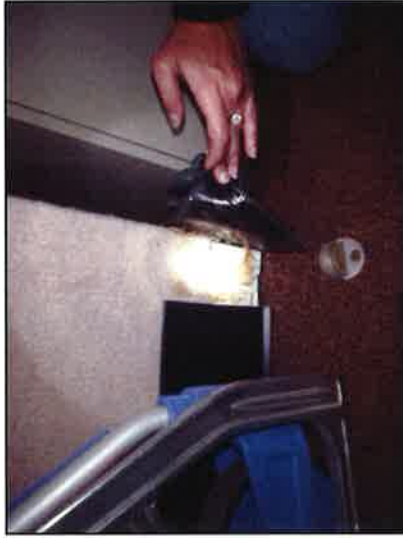
MM22  
Pink Fuzzy Wall Covering

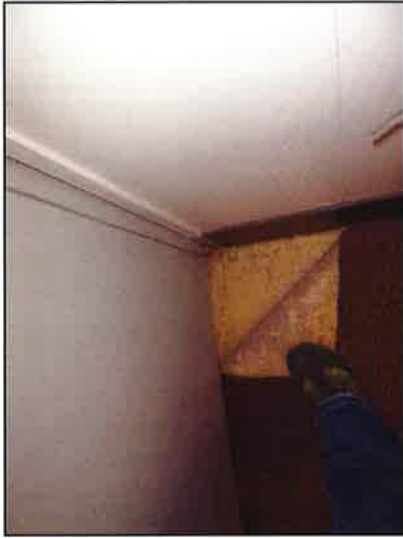
MM23  
9' Tan Floor Tile with Mastic

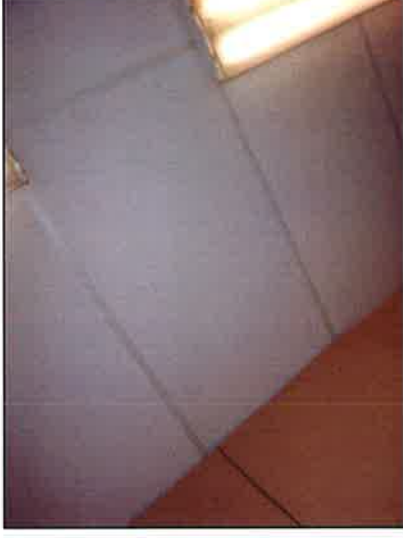
MM24  
2' x 4' White Ceiling Tile with Small Holes

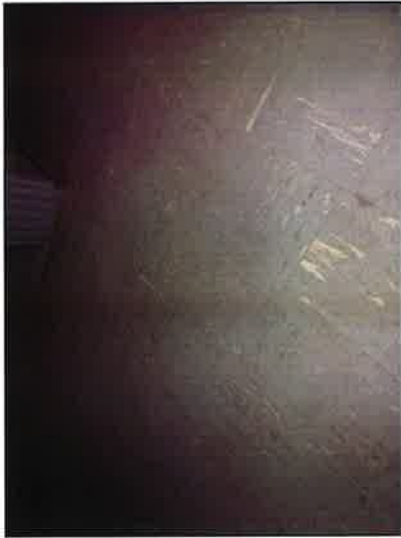
MM25

9" Gray Floor Tile with Tan Streaks and Mastic

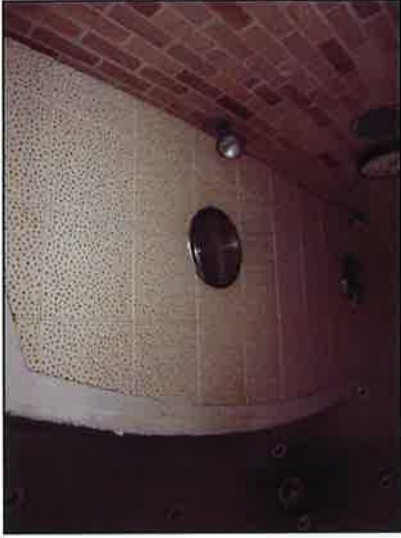
MM26

1' x 1' White Ceiling Tile with Holes

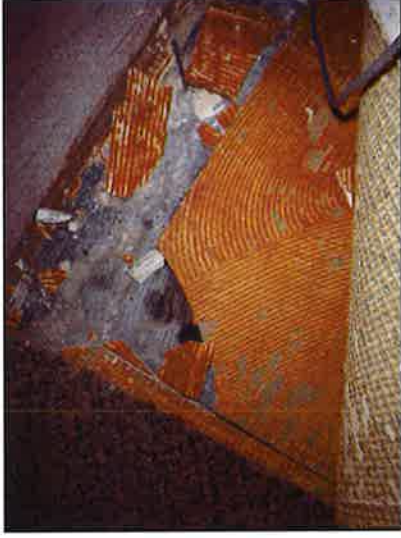
MM27

9" Green Floor Tile with Mastic

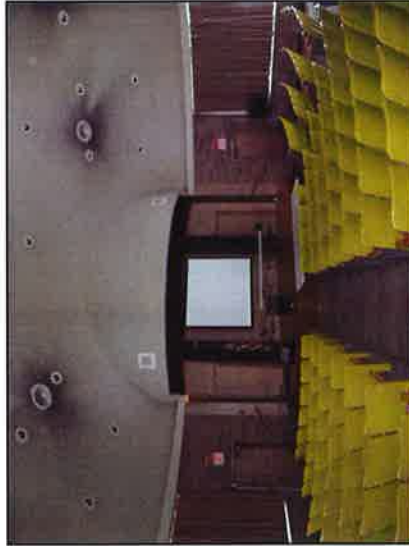
MM30

For the purpose of this inspection fire doors and door frames, elevator brake shoes, curtains in the auditorium, panels behind the radiators and roofing materials were noted throughout the buildings, because of the destructive nature of sample collection and the resulting risk of integrity to the materials, Global did not sample the doors, door frames, elevator brake shoes, auditorium curtains, paneling or roofing and they should be assumed ACBM unless sampled at a later time.

Blue Stage Curtain

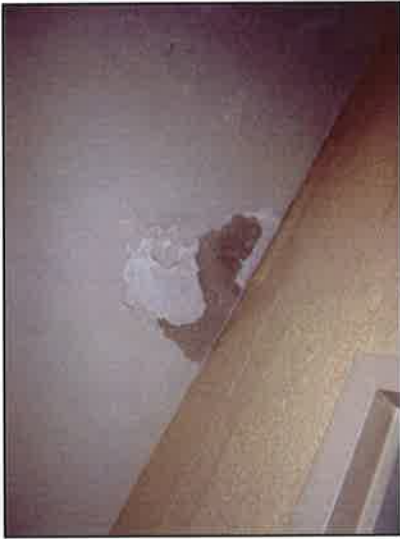
SM1  
Plaster

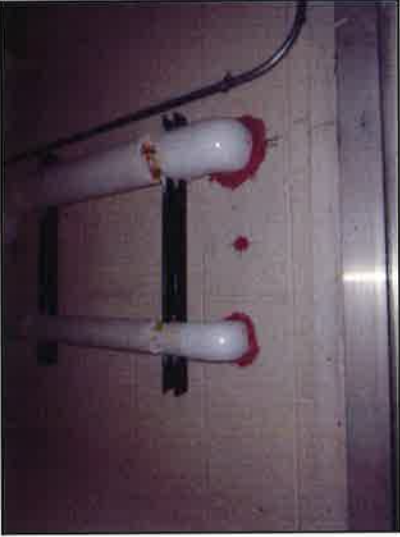
SM2  
Pink Caulk

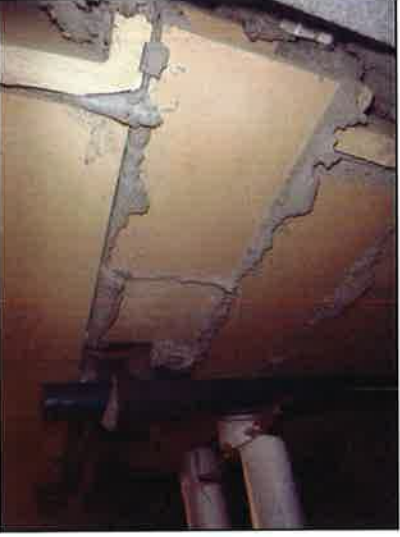
SM3  
Brick Mortar

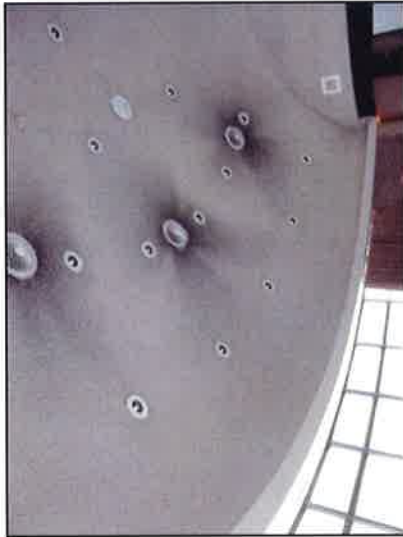
SM4  
White Spray On Material

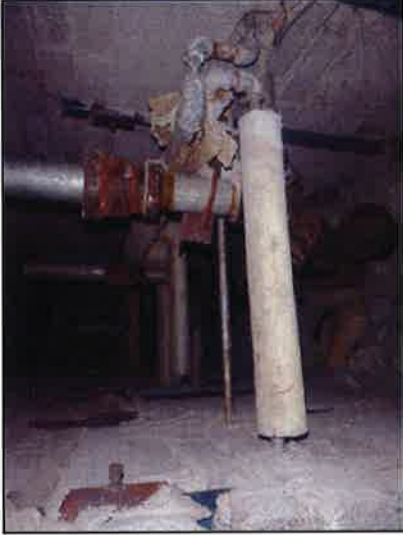
The results of the asbestos survey identified friable and non-friable ACBMs within the buildings. The friable ACBMs consisted of 2' x 4' ceiling tiles, mill board pipe insulation straight runs, mudded fittings on both mill board and fiberglass runs and boiler lagging. Physical examination of these materials identified areas of damaged/exposed ends, damaged or missing fitting insulation; and damaged or missing canvas wrap and is considered damaged to significantly damaged. Federal and state regulations require that anyone disturbing asbestos containing materials are properly trained, certified and have the required respiratory protection and medical surveillance.

TS11  
Millboard Runs

The friable ACBMs are located above drop ceilings, in pipe chases, in the boiler room or in the basement of the police department which are not common work spaces. Caution labels should be attached to areas containing friable ACBM. If the area located above the drop ceiling is to be renovated or disturbed in areas that ACBM were identified, Global recommends contracting a trained and licensed asbestos abatement contractor to remove, encapsulate or enclose all friable ACBM. Contractors and/or reviewers of this report should contact the building owner as to renovation plans including questions pertaining to removal and encapsulation for the structure.

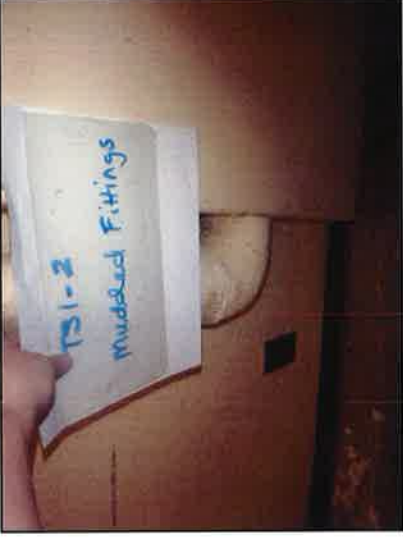
TS12  
Mudded Fittings on Fiberglass Runs

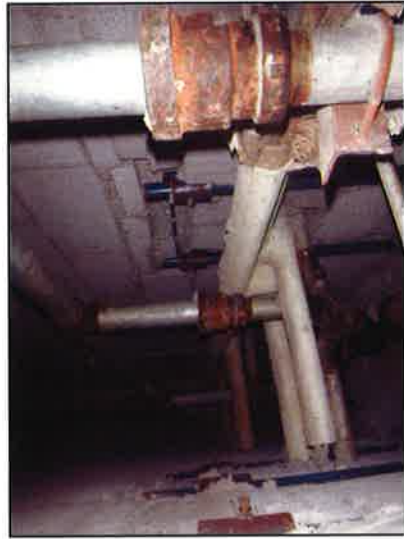
TSI3  
Millboard Run Fittings

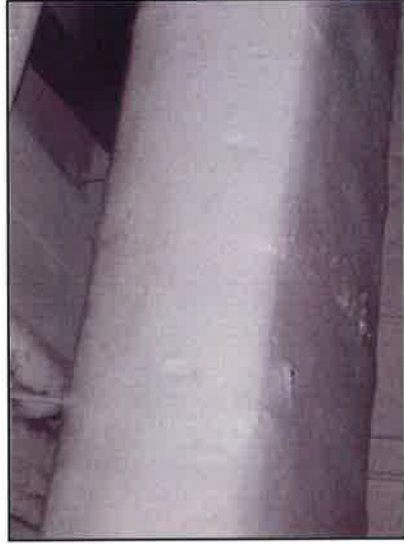
TSI4  
Canvas Wrap over Fiberglass Duct Work

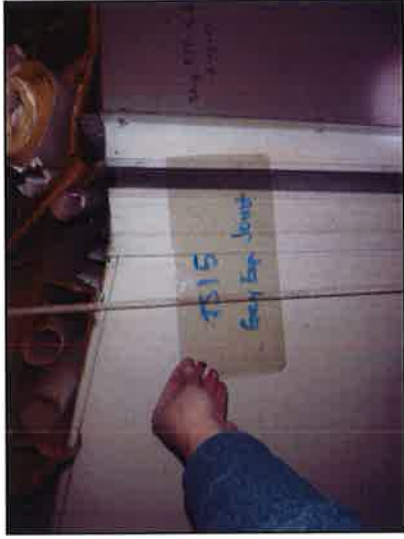
TSI5  
Expansion Joints

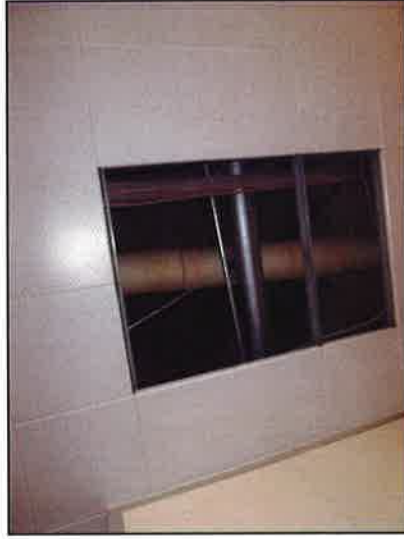
TSI6  
6" Millboard Run
