ASBESTOS-CONTAINING BUILDING MATERIALS AND  
LEAD PAINT SURVEY

**N. GRAND TRAVERSE STREET  
BRIDGE, OVER THE FLINT  
RIVER**

FLINT, MICHIGAN

G2 Project No. 250359  
January 23, 2026

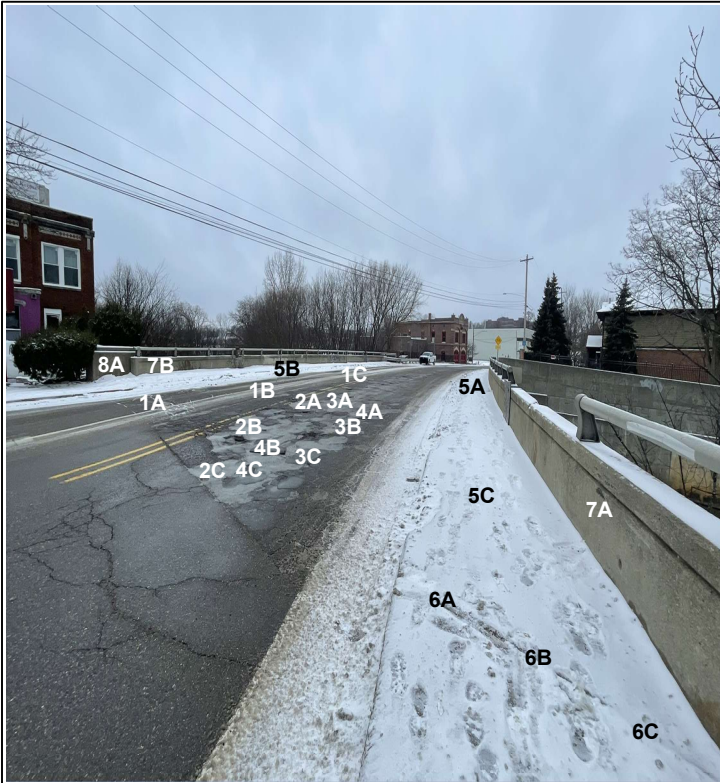
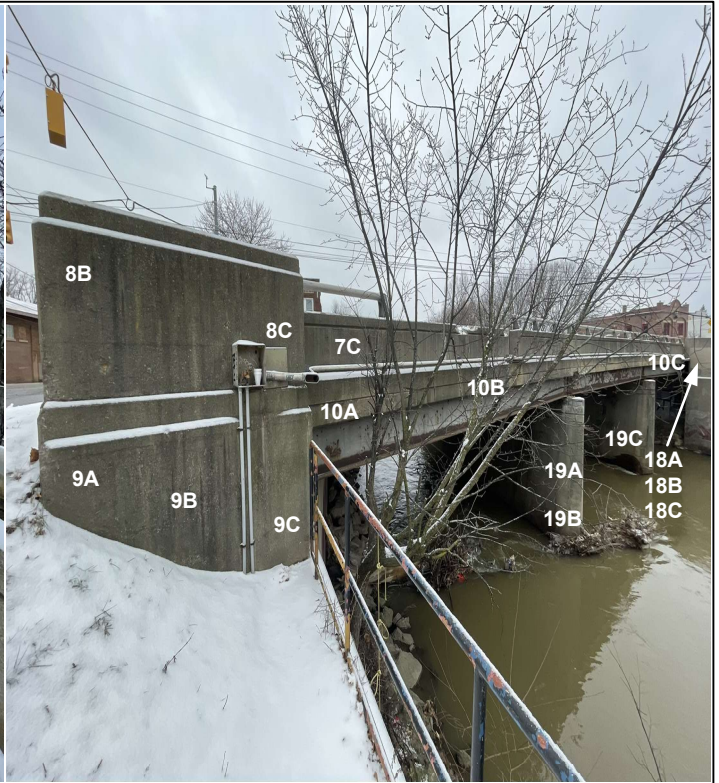
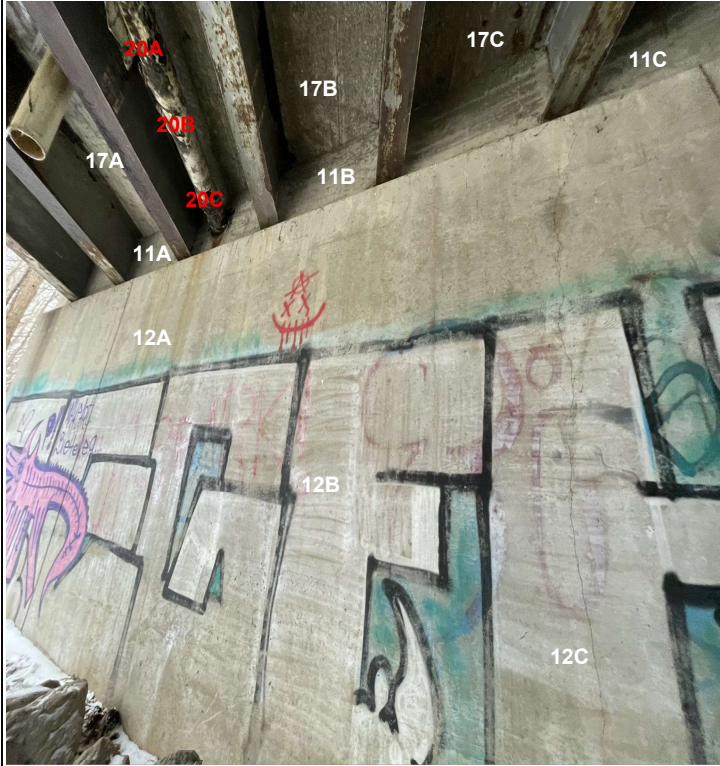
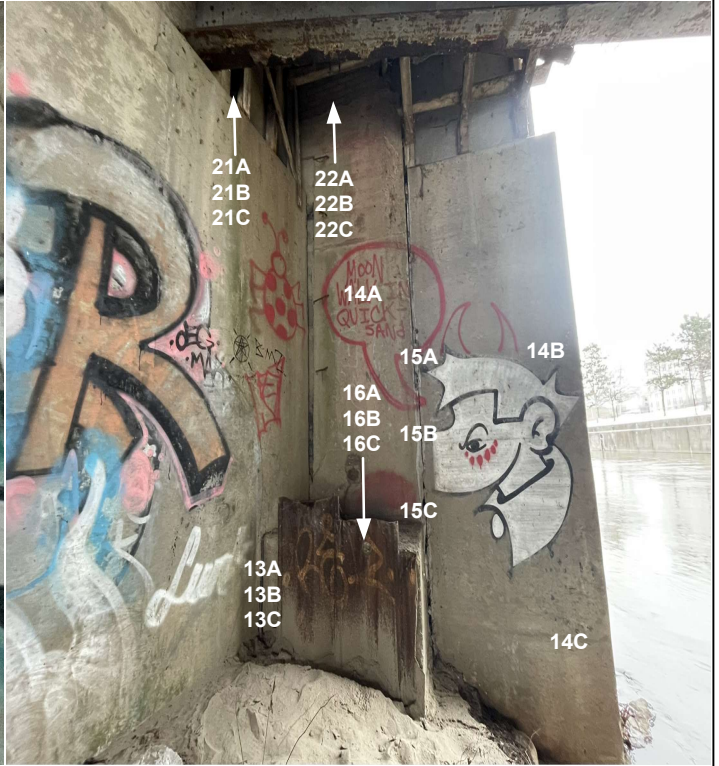
Figure 1

**Pipe Wrap (HA# 20)** – This friable thermal system insulation material wraps an 8-inch diameter pipe that runs the length of the underside of the bridge. The material is noted to be in poor physical condition with areas deteriorated or missing. Approximately 145-linear feet of this friable material is visible and G2 notes that more may be present in inaccessible areas.

The identified pipe insulation is RACBM.

**Bulk Sampling Location Plan**

In summary, one of the sampled building/bridge materials were identified as being ACBM, the pipe insulation (HA#20). This friable material is RACBM and should be removed by a licensed and qualified asbestos abatement contractor prior to any planned disturbance. Furthermore, if new or additional surfaces are identified and may be impacted as a result of the completed modification/demolition, they should be properly evaluated prior to the planned modification/demolition activities.
