DORT RESERVOIR  
STRUCTURAL REHABILITATION

OVERALL PLAN

FLINT	MICHIGAN
<b>DORT RESERVOIR STRUCTURAL REHABILITATION</b>	
<b>REHABILITATION DETAILS</b>

MICHIGAN  
 DORT RESERVOIR  
 STRUCTURAL REHABILITATION  
 REHABILITATION DETAILS

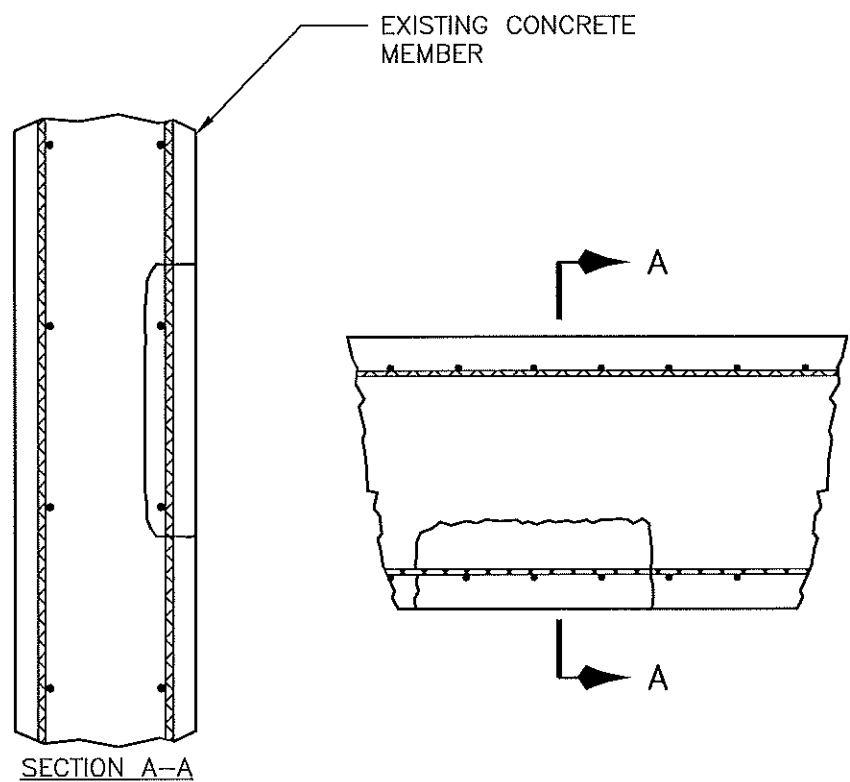
1  
S1.1

1. THE EXTENT OF THE AREA TO BE REPAIRED SHALL BE DETERMINED BY THE CONTRACTOR AND APPROVED BY THE ENGINEER BY TAPPING THE CONCRETE WITH A HAMMER TO FIND THE PERIMETER EDGES WHERE UNSOUND MATERIAL MEETS SOUND MATERIAL.

2. PERIMETER OF REPAIR AREA SHALL BE SAW CUT PERPENDICULAR TO THE SURFACE TO A MINIMUM DEPTH OF 1/2". PERIMETER OF PATCH AREA SHALL HAVE STRAIGHT EDGES 90 DEGREE CORNERS AND NO RE-ENTRANT CORNERS. PATCH AREAS SHALL BE EITHER SQUARE OR RECTANGULAR.

3. REMOVE ALL UNSOUND CONCRETE DOWN TO SOUND CONCRETE USING LIGHTWEIGHT PNEUMATIC HAMMERS. ANY REINFORCEMENT THAT IS EXPOSED DURING THIS PROCESS SHALL BE COMPLETELY EXPOSED BY REMOVING CONCRETE TO 3/4" BEYOND THE BAR LEAVING THE ENTIRE CIRCUMFERENCE EXPOSED. FINAL PATCH DEPTH SHALL BE UNIFORM (+/- 1/4") AND SHALL NOT BE LESS THAN 1". IF MORE THAN 30% OF THE BAR CROSS SECTION AREA IS LOST, REPLACE WITH SAME SIZE NEW BAR.

4. ENTIRE CONCRETE SURFACE OF REPAIR AREA SHALL BE MECHANICALLY ABRADED.
5. ALL EXPOSED REBAR SHALL BE CLEANED OF CORROSION BY EITHER SANDBLASTING OR GRINDER. REMOVE ALL LOOSE SCALE AND CORROSION DEPOSITS. STEEL SHALL BE CLEANED TO A BRIGHT CONDITION PAYING PARTICULAR ATTENTION TO THE BACK OF THE EXPOSED BARS. DO NOT USE WIRE BRUSH FOR CLEANING REINFORCEMENT.

6. COAT ENTIRE CIRCUMFERENCE OF ALL EXPOSED REINFORCING STEEL WITH EPOXY BONDING.
7. CONCRETE SURFACE TO BE REPAIRED SHALL BE PREPARED IN ACCORDANCE WITH PATCHING SYSTEM MANUFACTURER'S REQUIREMENTS.

8. REPAIR AREA BY INSTALLING THE PATCHING MORTAR AND CURING IN ACCORDANCE WITH THE MANUFACTURER'S INSTRUCTIONS.

CONCRETE PATCHING

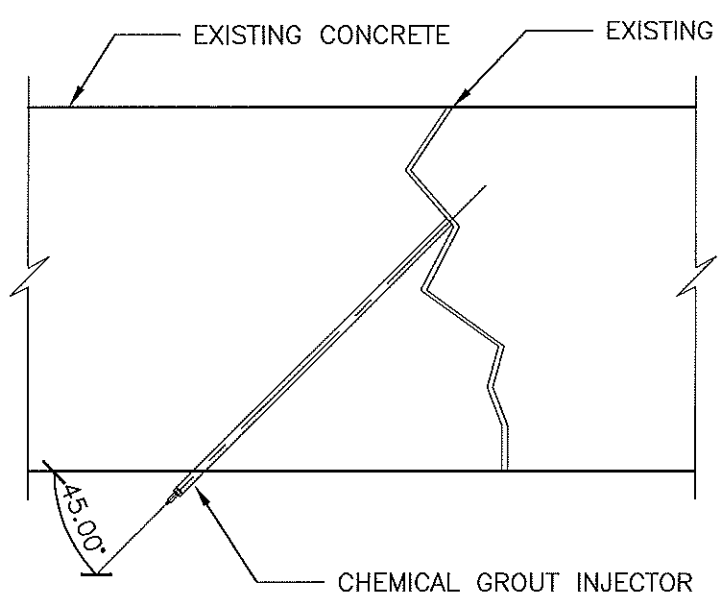
2  
S1.1

1. PREPARE CRACK AND INJECT CHEMICAL GROUT PER MANUFACTURER'S RECOMMENDATIONS.
2. CONTRACTOR TO ASSUME A TOTAL UNDISTRIBUTED QUANTITY OF XX LFT OF CRACK REPAIR

TYPICAL CONCRETE CRACK REPAIR

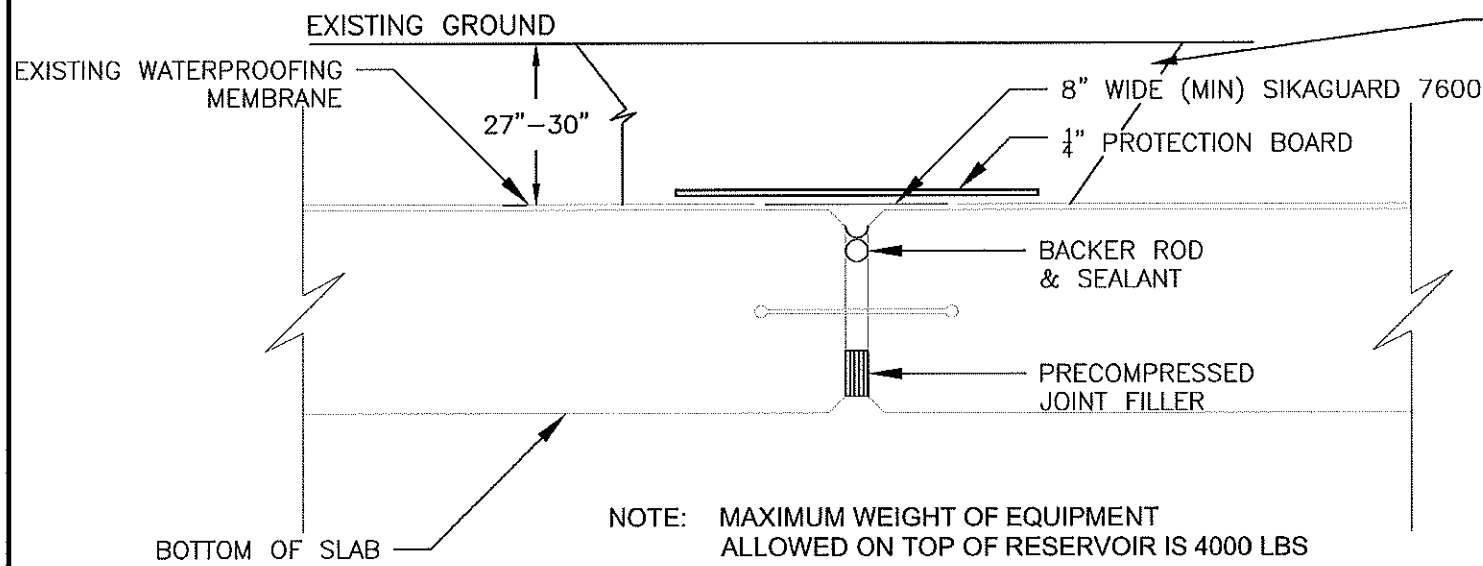
3  
 S1.2

EXCAVATE TRENCH TO ACCESS JOINT.  
 BACKFILL AND PLACE 4" TOPSOIL SEED AND MULCH.

1. CUT BACK/REMOVE EXISTING WATERPROOFING MEMBRANE, REMOVE EXISTING JOINT FILLER, POWERWASH, AND MECHANICALLY ABRADE TOP OF EXISTING SLAB PRIOR TO INSTALLATION OF TOP SLAB MATERIALS. TURN UP/DOWN A MINIMUM OF 1'-0" AT EXTERIOR EDGE OF TANK.
2. PRIME EXISTING CONCRETE AND REINFORCE SIKAGUARD 7600.
3. APPROXIMATELY 2'-3" OF FILL EXISTS ABOVE CONCRETE SLAB. FILL SHALL BE REMOVED AND REINSTALLED PER ORIGINAL DRAINAGE DETAILS.
4. SEALANT TO BE SIKA 2C NS EZ.
5. PRECOMPRESSED JOINT FILLER TO BE EMSEAL SUBMERSEAL WITH PREFABRICATED 90 DEGREE CORNERS.
6. BIDS ARE TO BE BASED ON 1100 LFT OF ROOF EXPANSION JOINT REPAIR.

NOTE: MAXIMUM WEIGHT OF EQUIPMENT  
 ALLOWED ON TOP OF RESERVOIR IS 4000 LBS

### TOP SLAB EXPANSION JOINT REPAIR

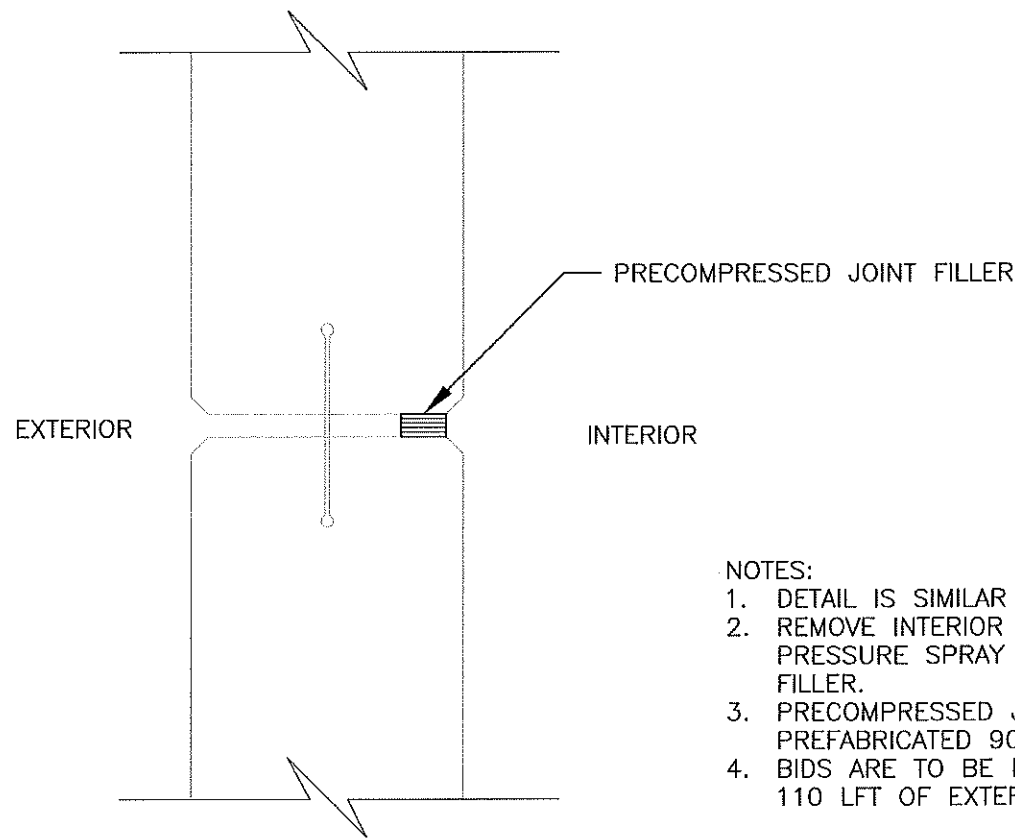
4  
 S1.2

1. DETAIL IS SIMILAR AT BASE SLAB.
2. REMOVE INTERIOR JOINT FILLER AND POWER WASH WITH HIGH PRESSURE SPRAY PRIOR TO INSTALLATION OF PRECOMPRESSED JOINT FILLER.
3. PRECOMPRESSED JOINT FILLER TO BE EMSEAL SUBMERSEAL WITH PREFABRICATED 90 DEGREE CORNERS.
4. BIDS ARE TO BE BASED ON 1100 LFT OF BASE SLAB REPAIR AND 110 LFT OF EXTERIOR WALL REPAIR.

### EXTERIOR WALL AND BASE SLAB EXPANSION JOINT REPAIR

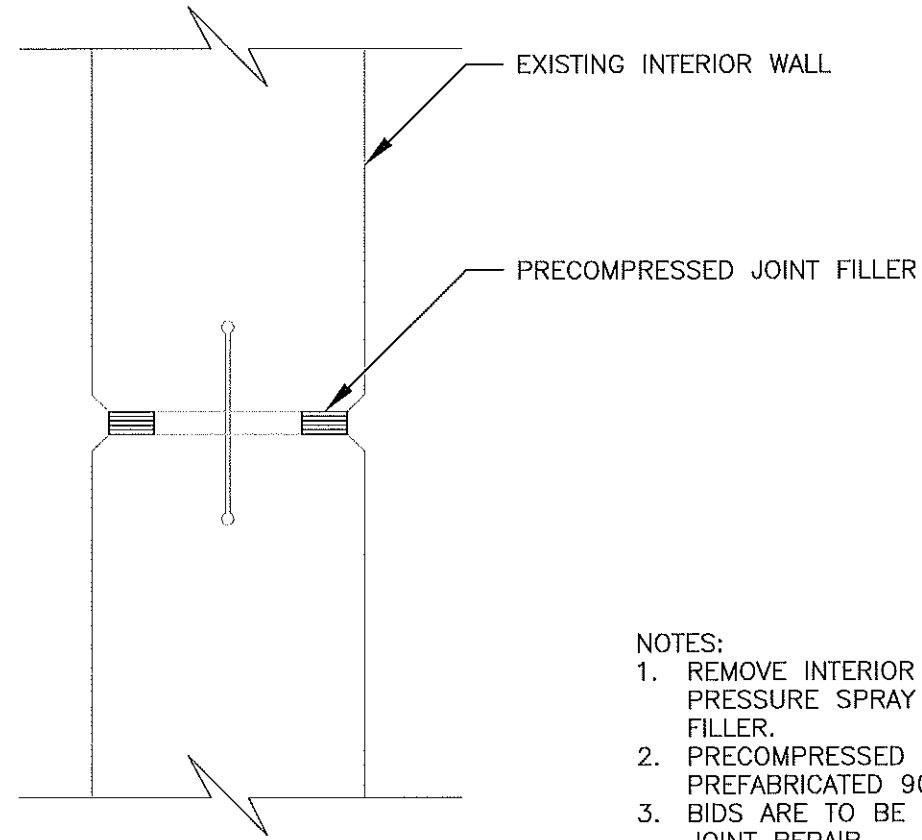
5  
S1.3

1. REMOVE INTERIOR JOINT FILLER AND POWER WASH WITH HIGH PRESSURE SPRAY PRIOR TO INSTALLATION OF PRECOMPRESSED JOINT FILLER.
2. PRECOMPRESSED JOINT FILLER TO BE EMSEAL SUBMERSEAL WITH PREFABRICATED 90 DEGREE CORNERS.
3. BIDS ARE TO BE BASED ON 70 LFT OF INTERIOR WALL EXPANSION JOINT REPAIR

INTERIOR WALL EXPANSION JOINT REPAIR

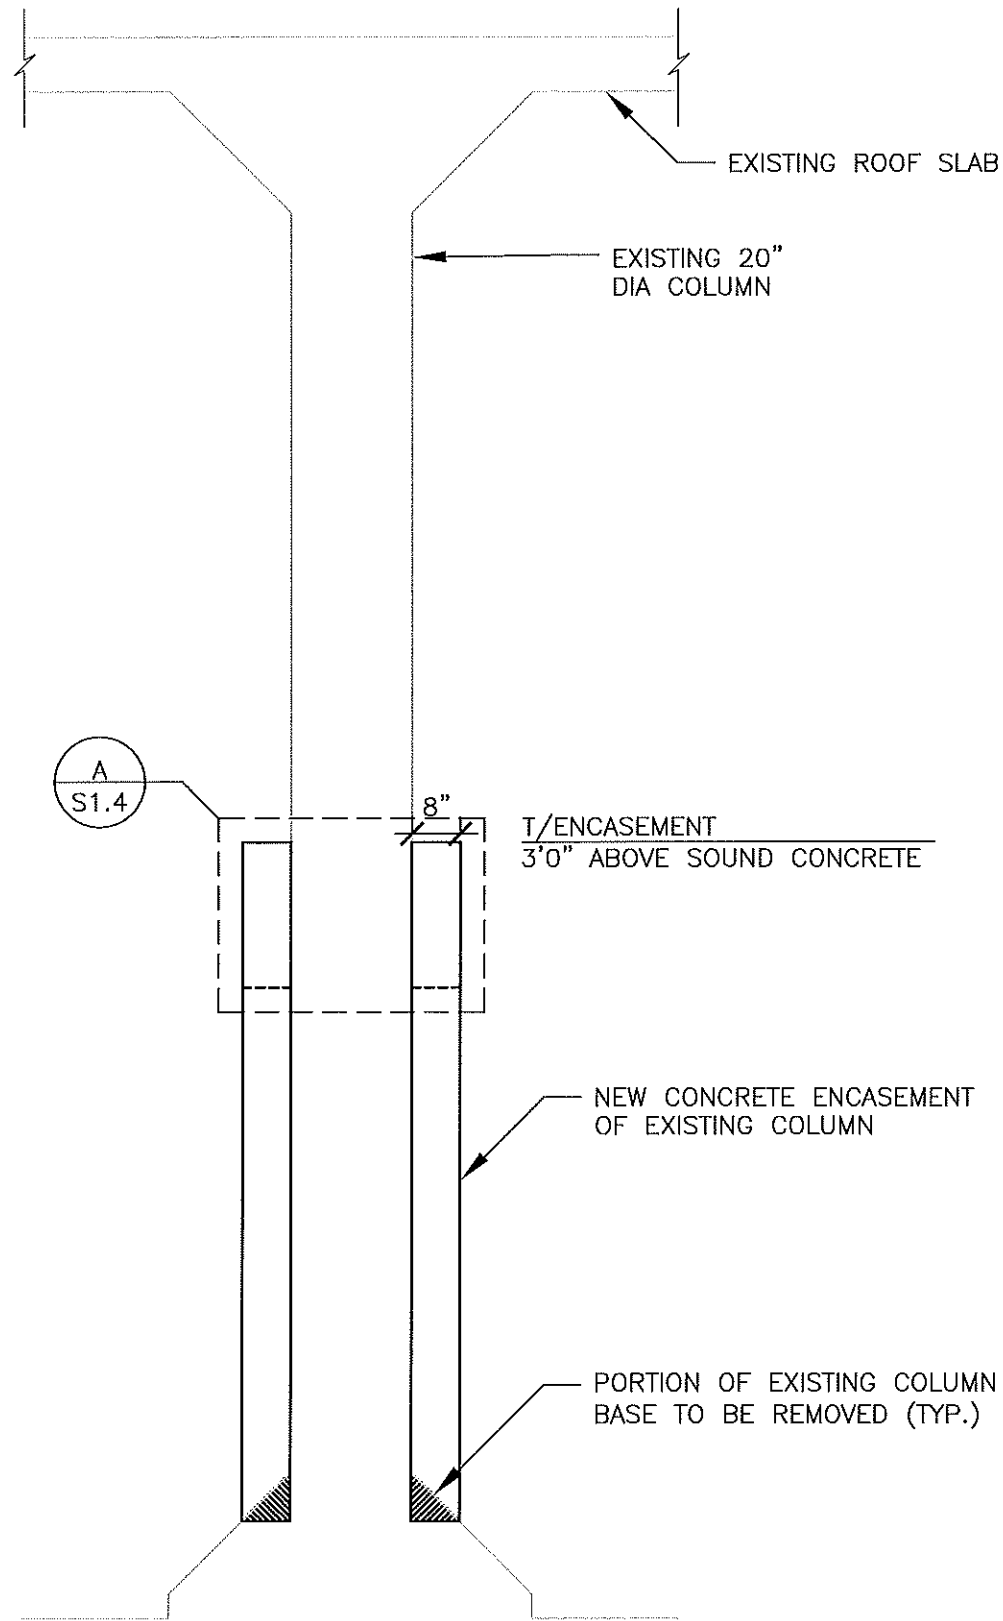
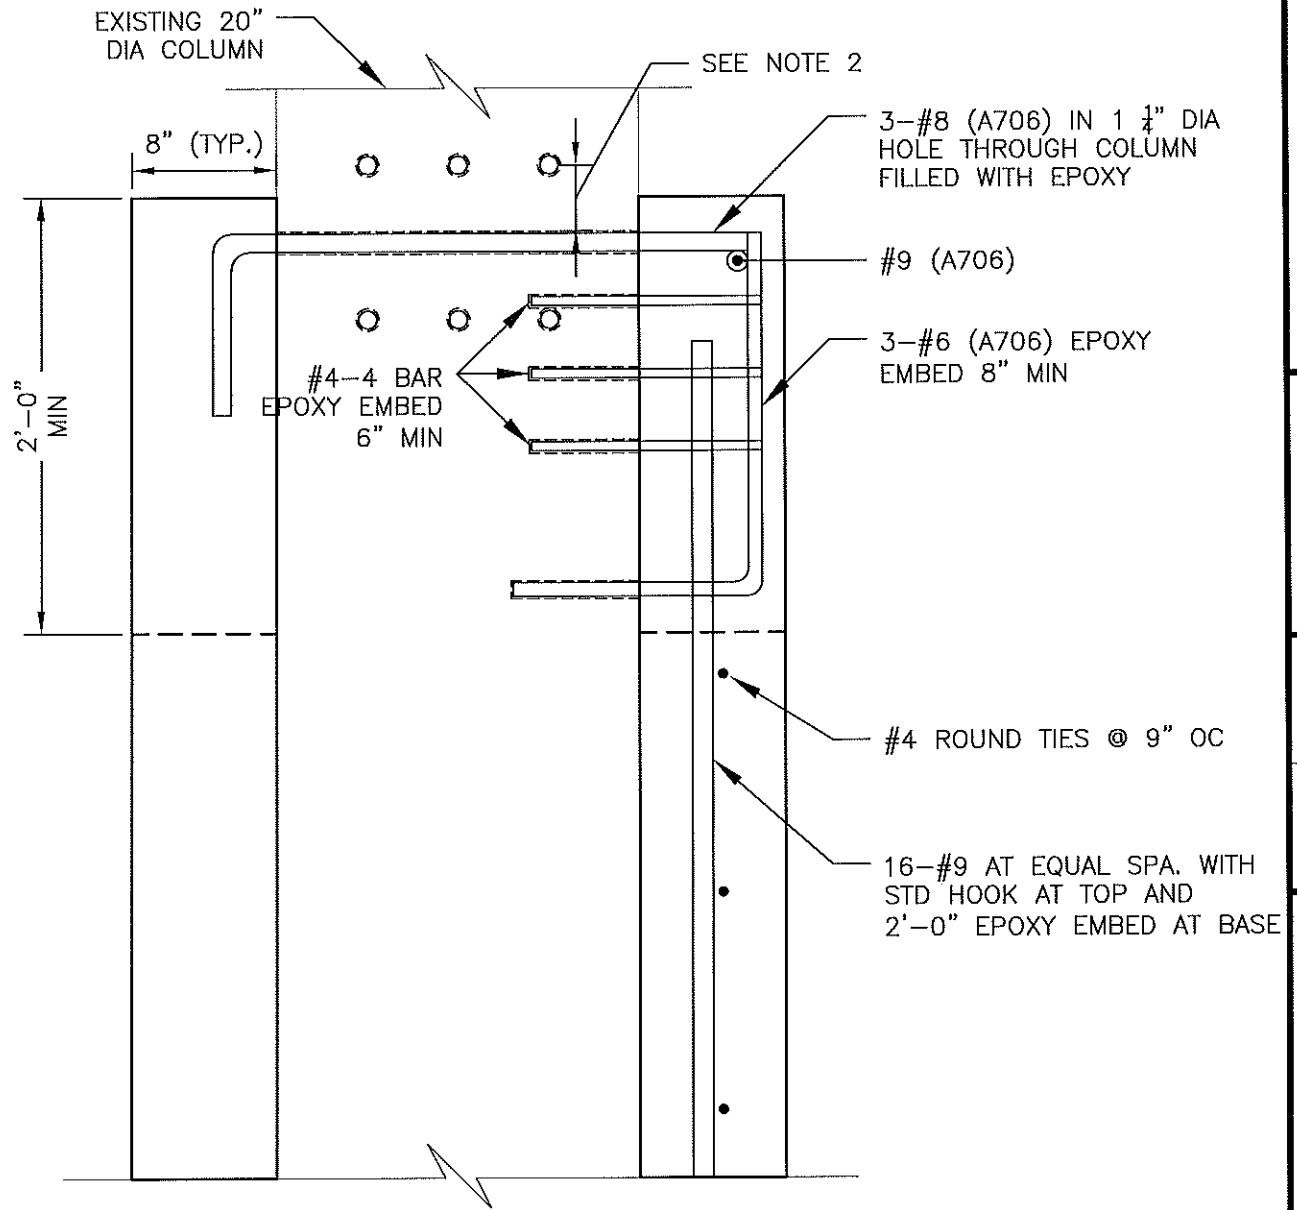
### COLUMN REPAIR - REINFORCEMENT

### COLUMN REPAIR
